TD041 – Tefcote Materials Testing

To determine the compatibility of two different finishes on concrete substrate found in the construction of clean rooms to Hydrogen Peroxide Vapour (HPV) decontamination cycles.

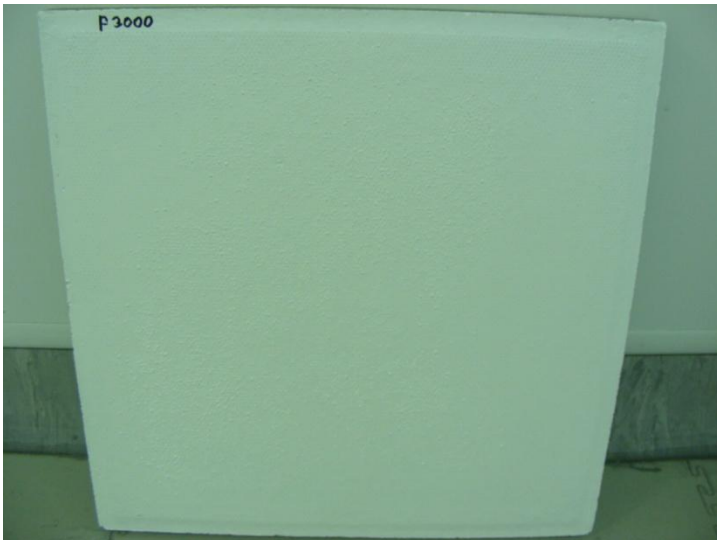
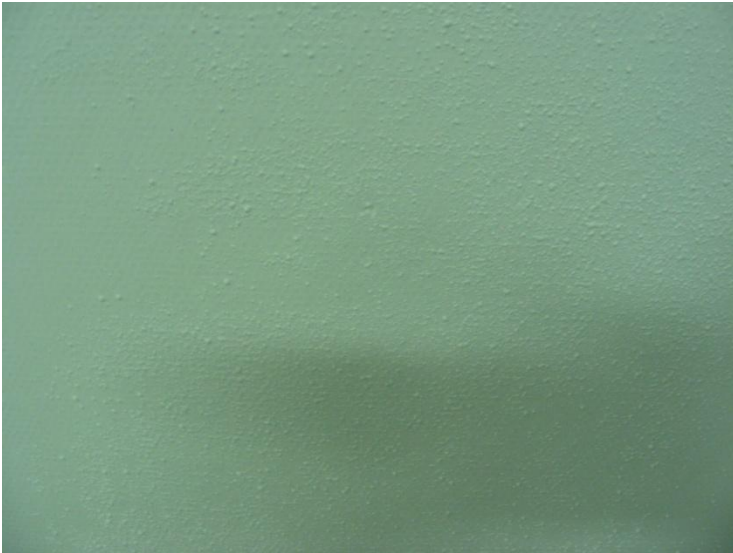
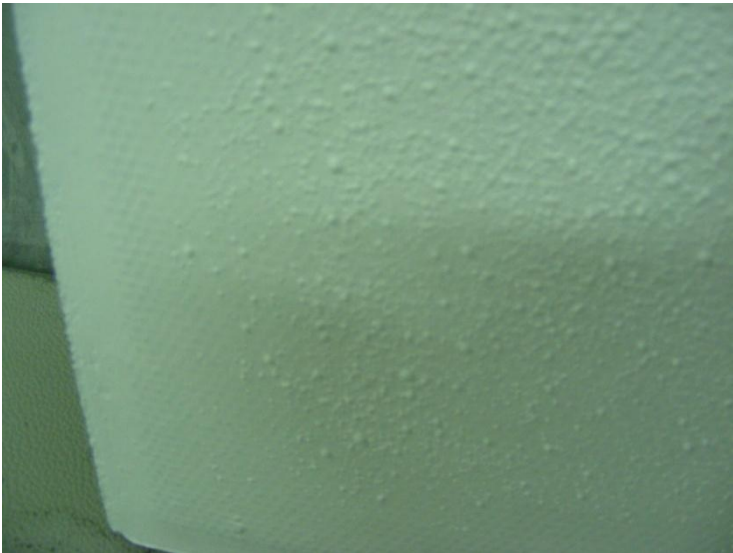
After 9 cycles

The Tefcote 3000 coating had deteriorated badly by the 9th cycle. The fact that the sample had not been allowed to cure for the required period stated by the manufacturer may have contributed to the damage.

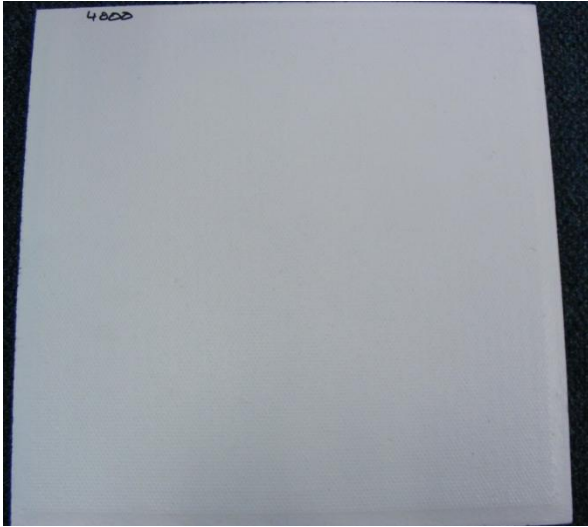
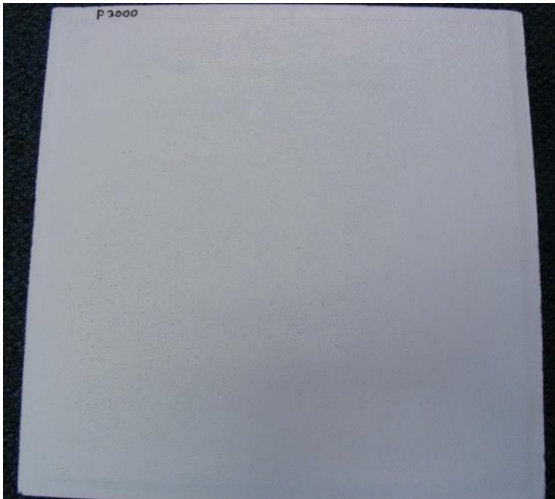
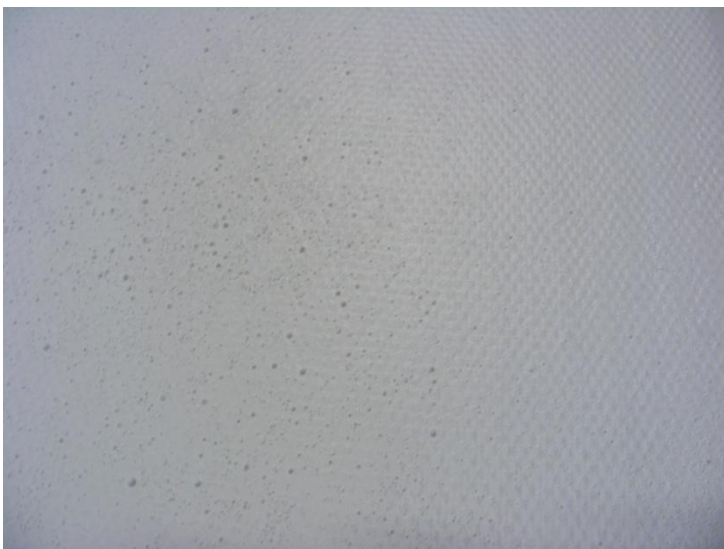
At End

The Tefcote 4000 did not show any signs of deterioration.
