TD041 – Tefcote Materials Testing

To determine the compatibility of two different finishes on concrete substrate found in the construction of clean rooms to Hydrogen Peroxide Vapour (HPV) decontamination cycles.

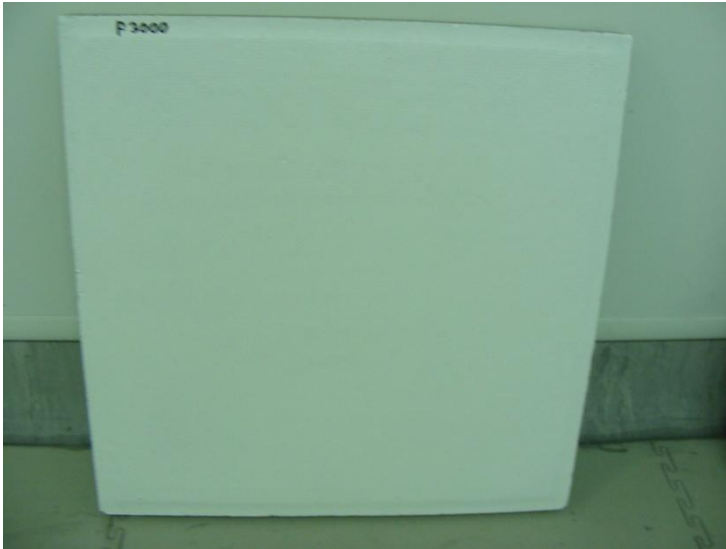
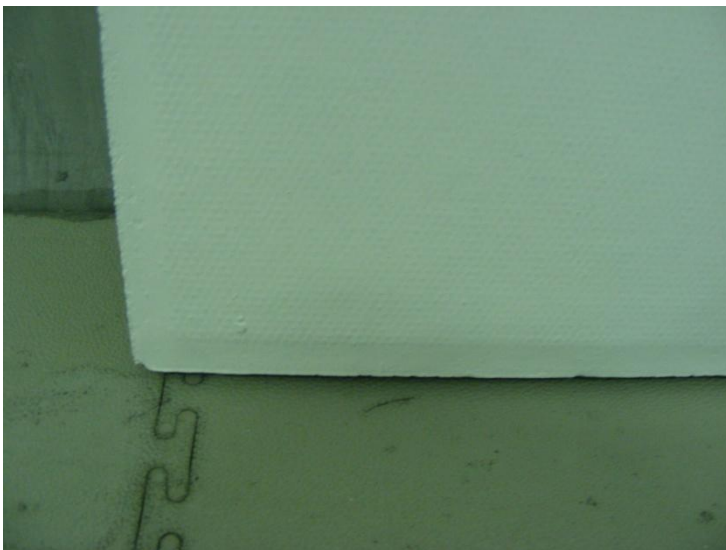
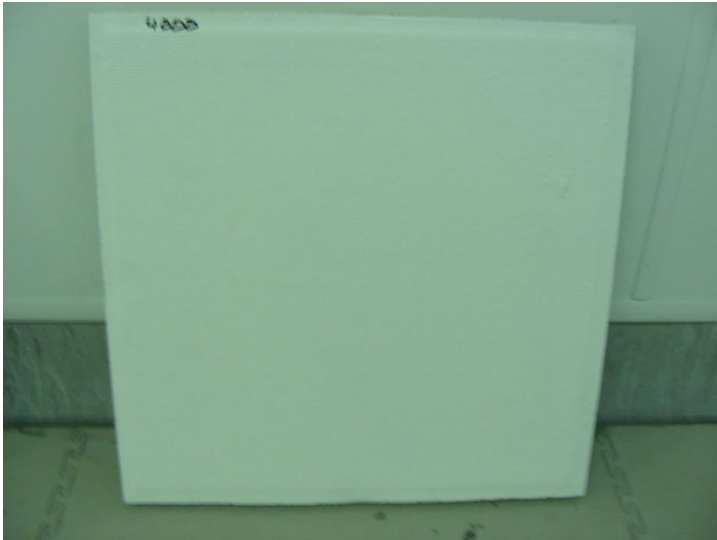
Start Photos

The samples were photographed three times pre-test, after 9 cycles and post test (40 cycles). The three photographs are shown for each sample.
